MAJOR ENERGY CONSERVATION RETROFITS

A Planning Guide For Northern Climates

Prepared for:
U.S. Department of Energy
Assistant Secretary, Conservation and Renewable Energy
Small Scale Technology Branch
Appropriate Technology Program
Under Contract No. DE-AC01-82CE15095

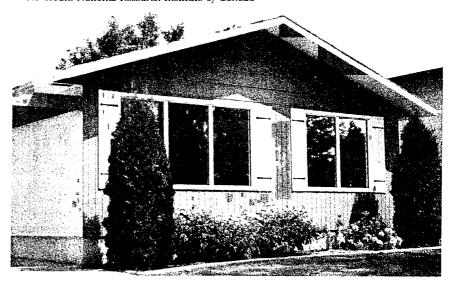
Before the Retrofit: R-8 walls R-15 ceilings

Double glazing Yearly electrical usage: 40,062 kWh

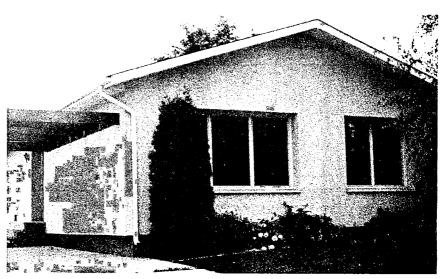
After the Retrofit: R-48 walls R-55 ceilings

Triple glazing Yearly electrical usage: 7,057 kWh

work that was planned. The retrofit work has resulted in a \$1,155 a year savings in electric bills. The energy conservation investment will pay back in 111/4 years.

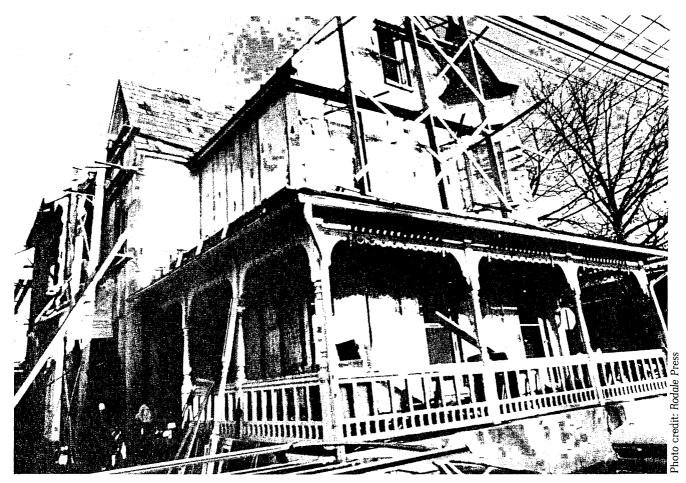
FIGURE 2.2 A grantee in Pennsylvania decided on an exterior retrofit of this historic structure so that the building tenants could remain in the house during construction. Photo credit: Rodale Press.

Another important consideration is whether the house will be occupied during the retrofit. There should be little inconvenience to the occupants with an exterior retrofit, whereas an interior retrofit involves demolition and construction that would be difficult with the building occupied. It might be possible to work on one room at a time, but this technique is generally more costly and the construction mess is still unavoidable (Figure 2.2).

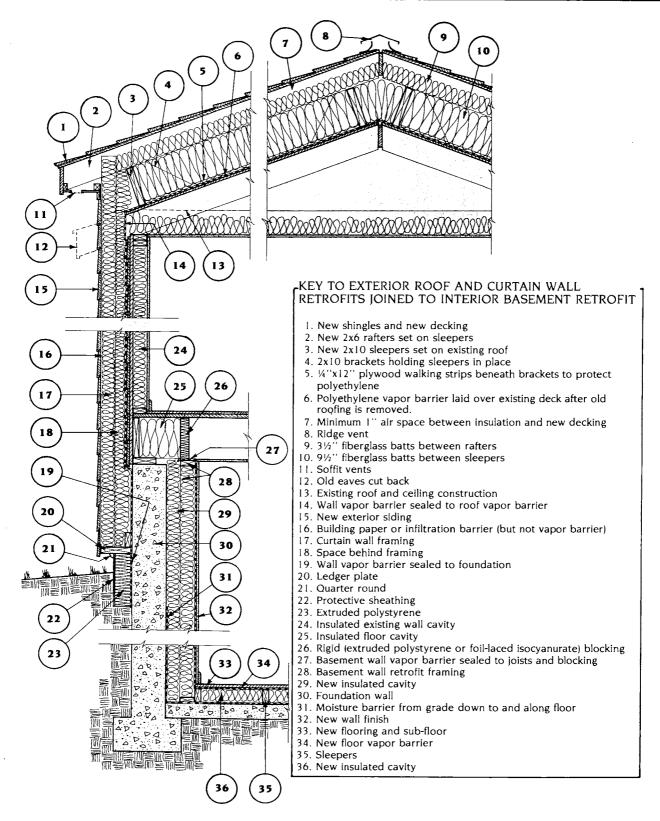
FIGURE 2.3 Exterior roof and curtain wall retrofits joined to an interior basement retrofit.

ever, combining interior and exterior strategies can cause complications when it comes to joining the vapor barriers through the existing perimeter walls, floors and ceilings of the house (Figure 2.3).

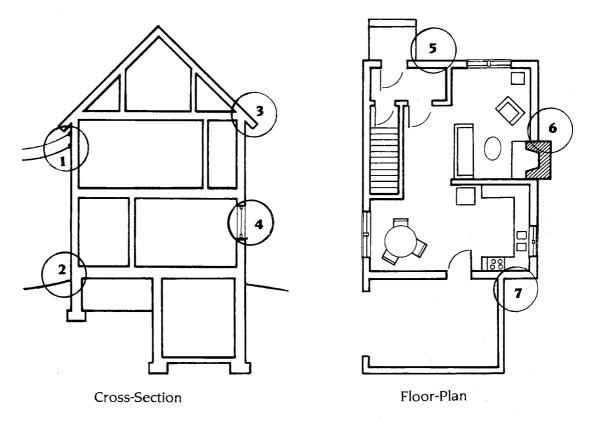
- 1. Utility hook-ups (electric, water, sewer, gas, telephone, etc.)
- 2. Main wall/foundation wall
- 3. Eaves
- 4. Windows/doors
- 5. Abutting objects (sidewalk, stoop, driveway, wing-wall)
- 6. Fireplace/chimney
- 7. Non-insulated adjoining spaces (garage, porch)

FIGURE 2.4 Problem areas - Exterior retrofit.

However, there are a number of details that can cause difficulty and extra expense (Figure 2.4). These problem areas can usually be identified by examining structural systems, existing exterior finishes, vapor barriers, exterior obstacles, and door and window openings.

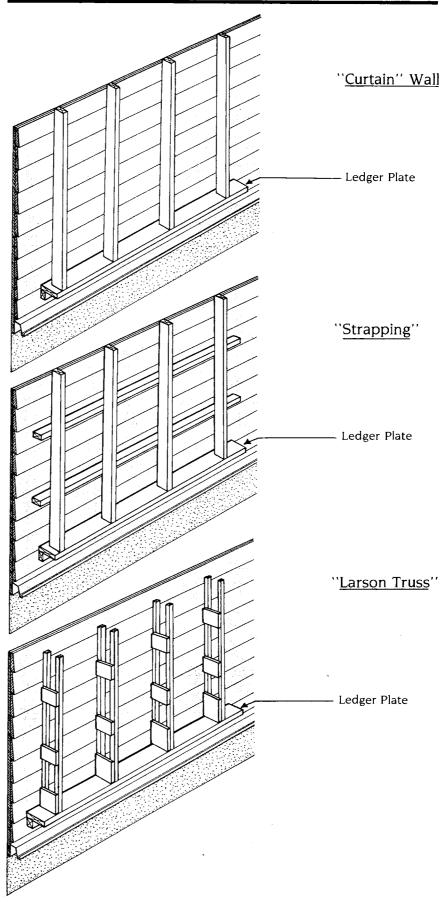
FIGURE 2.5a Three exterior retrofit framing methods.

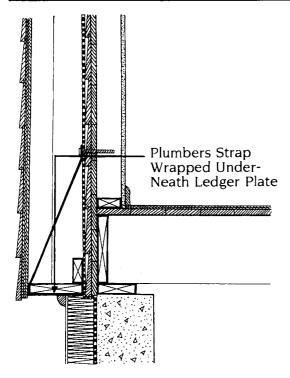
Ledger Plate Secured With Plumber's Strap And Screwed To Existing Studs At 32 Or 48 Inches O.C.

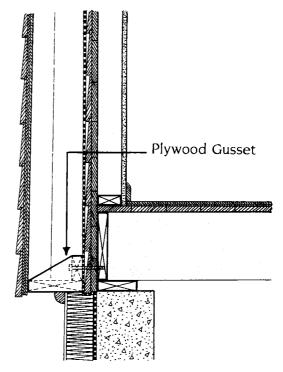
48 Inch Sections Of Ledger Plate With Plywood Gussets At Ends, Lag-Screwed To Rim Joist

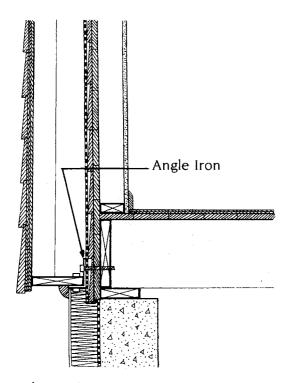
Ledger Plate Bolted To Angle Iron, Which Is In Turn Secured To Rim Joist With Lag Screws

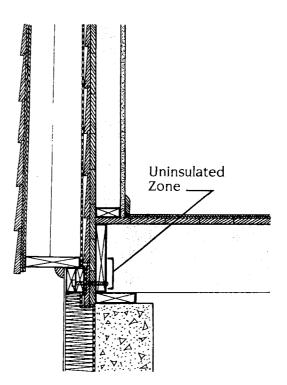
Ledger Plate Resting On Nailers Below (This Option Leaves A Wider Uninsulated Zone)

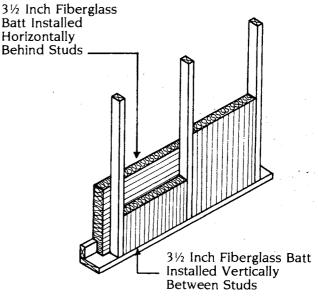
Two-Step Option

FIGURE 2.5c Insulation techniques for a 71/2-inch curtain wall retrofit.

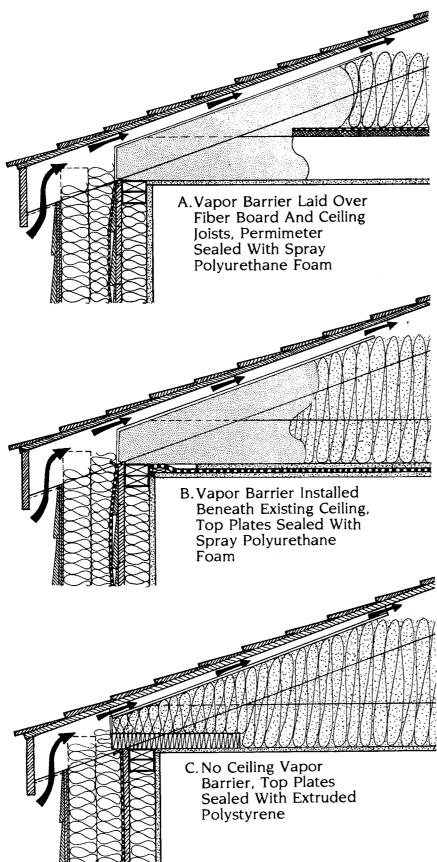
FIGURE 2.6 Exterior wall retrofit with an interior attic retrofit.

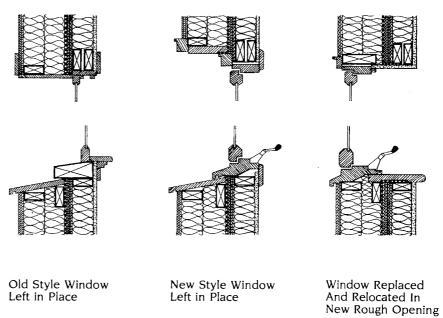
FIGURE 2.7 Options for exterior retrofits around window openings.

The condition of the existing windows should determine whether they are used or replaced. How many layers of glazing do they have? Can they be made to fit reasonably tight? Are the sash and other window components sound enough to merit keeping them? If existing windows are used, the window openings will be relatively deep and exterior extender jambs need to be installed. Storm windows will probably be needed to increase the R-value of existing windows. If new window units are installed, they can be mounted in the other portion of the rough opening. With new windows, interior jamb extenders must be added to match existing interior finishes (Figure 2.7).

Deciding how to finish and trim around the windows is simply a matter of taste. More important is the seal between the vapor barrier and the window opening (Figure 2.7). There are a variety of window configurations that might be encountered in retrofitting an old house, but in all cases the important steps when finishing window openings are to: 1) stop infiltration around the window unit; 2) design the new sill so that water drains away from the window opening; and 3) seal all exterior joints with caulk to keep moisture and air out of the wall. A poor seal around the exterior window frames coupled with the absence of a vapor barrier dramatically reduced the effectiveness of conservation work done by a grantee in Nebraska.

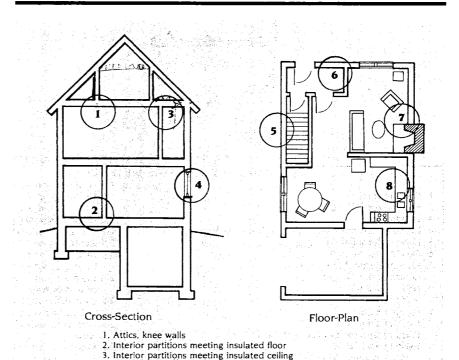
FIGURE 2.8 Problem areas - Interior retrofit.

4. Windows

6. Interior partitions meeting perimeter walls

8. Cabinets, cupboards, plumbing, wiring, fixtures

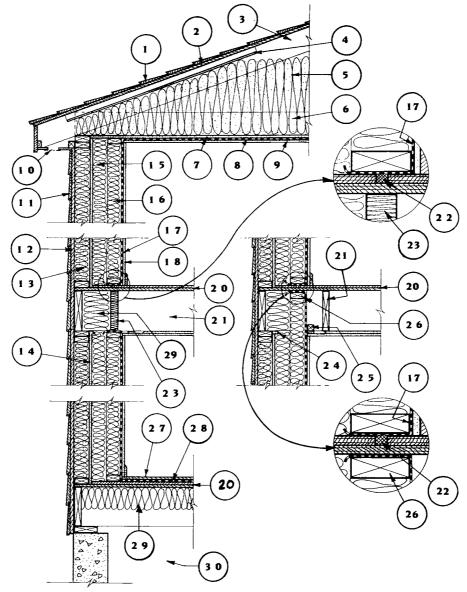
KEY TO INTERIOR RETROFIT WITH VAPOR BARRIER DIRECTLY BEHIND SHEETROCK

1. Existing shingles

- 2. Existing roof decking
- 3. Existing rafters
- 4. Baffle to prevent loose fill insulation from blocking vent path
- 5. Loose fill insulation
- 6. Existing ceiling joists
- 7. Existing ceiling finish
- 8. Ceiling vapor barrier
- 9. New ceiling finish
- 10. Soffit vent
- 11. Existing siding
- 12. Existing sheathing
- 13. Existing stud cavity filled with insulation
- 14. Existing wall finish
- 15. Cavity between old wall finish and new studs with insulation 16. New stud cavity filled with insulation

- 17. Wall vapor barrier
- 18. New wall finish
- 19. 2x2 stops to which tilt-up wall panels are sealed (Refer to drawing of tilt-up 2x4 framing).
- 20. Existing floor and sub-floor
- 21. Existing floor joists
- 22. Saw kerf filled with spray polyurethane foam to seal between floor and sub-floor
- 23. Rigid (extruded polystyrene or foil-faced isocyanurate) blocking sealed between joists
- 24. Old ceiling cut back
- 25. 2x2 ceiling nailer
- 26. New stud wall with top plate against upper floor
- 27. New floor
- 28. Floor vapor barrier
- 29. Batt insulation between joists
- 30. Crawl space

FIGURE 2.9a Interior retrofit with vapor barrier placed directly behind the sheetrock.

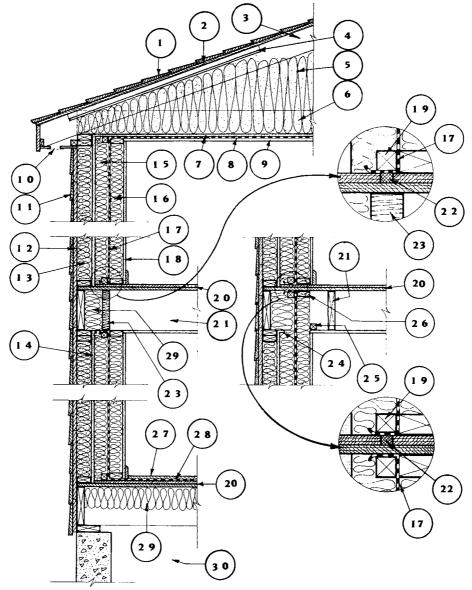
- 1. Existing shingles
- 2. Existing roof decking
- 3. Existing rafters
- 4. Baffle to prevent loose fill insulation from blocking vent path 20. Existing floor and sub-floor
- 5. Loose fill insulation
- 6. Existing ceiling joists
- 7. Existing ceiling finish
- 8. Ceiling vapor barrier
- 9. New ceiling finish
- 10. Soffit vent
- 11. Existing siding
- 12. Existing sheathing
- 13. Existing stud cavity filled with insulation
- 14. Existing wall finish
- 15. Cavity between old wall finish and new studs with insulation
- 16. New stud cavity filled with insulation

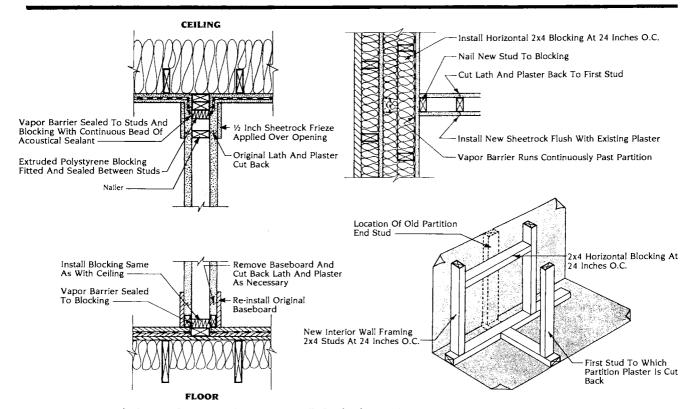
FIGURE 2.10 Details showing how vapor barrier is installed to bridge partitions.

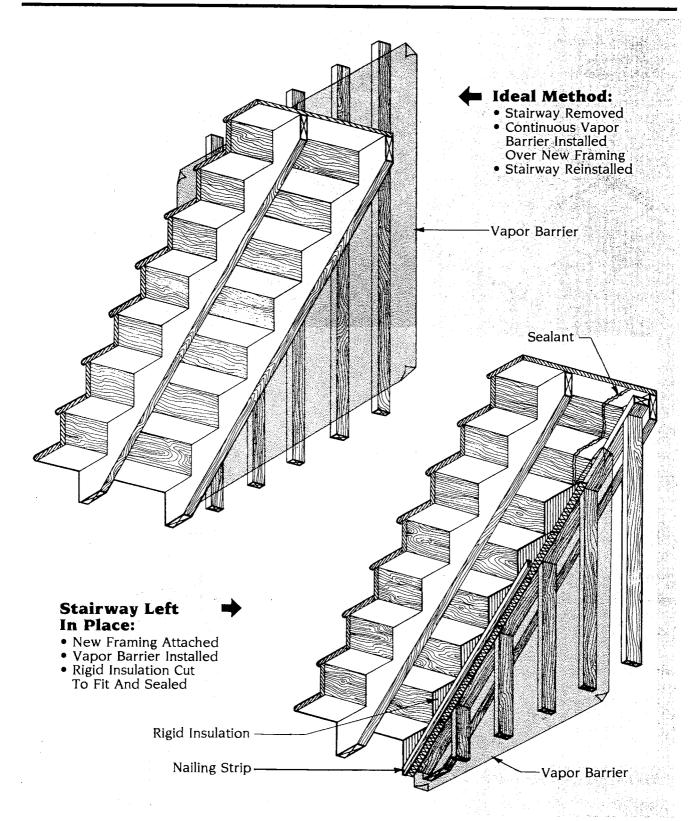
FIGURE 2.11 Installation of vapor barrier at stairway. (Underside view of stairway is shown.)

Other obstacles like cupboards and counters can be removed and reinstalled or replaced in order to attach the vapor barrier behind them: however, stairs are much more difficult and expensive to work around. Ideally, the stairs would be removed while the insulation and vapor barrier are fitted along the wall (Figure 2.11). This technique is costly unless the stairs need replacement anyway. A more realistic alternative is to leave the stairs in place and seal the vapor barrier to the stairs. While the task of sealing the vapor barrier to every tread and riser will be time consuming, this technique will be less expensive than rebuilding the stairs.

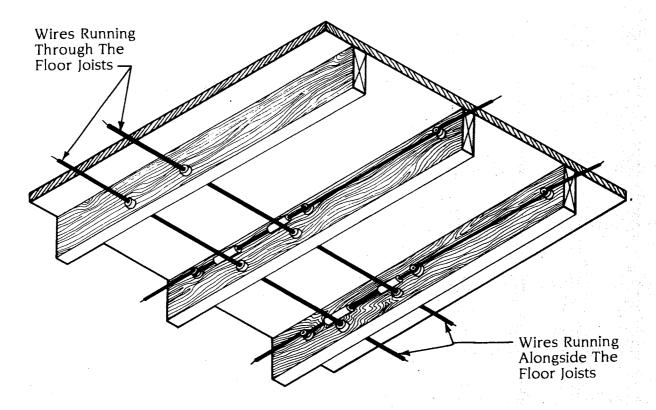
FIGURE 2.12 Knob and tube wiring.

Old electrical wiring presents a different kind of problem. Original electrical systems are often not sized to accommodate modern electrical needs. The old "knob and tube" wiring, common before 1930, is generally safe as installed, but when it is improperly spliced, it can overheat (Figure 2.12). This heat is usually released without a problem in an uninsulated wall cavity. But once the wire is surrounded by insulation, the temperature of the wire may reach the kindling temperature of surrounding materials and a fire is possible. This problem is aggravated in modern households that overload the old circuits with too many appliances.

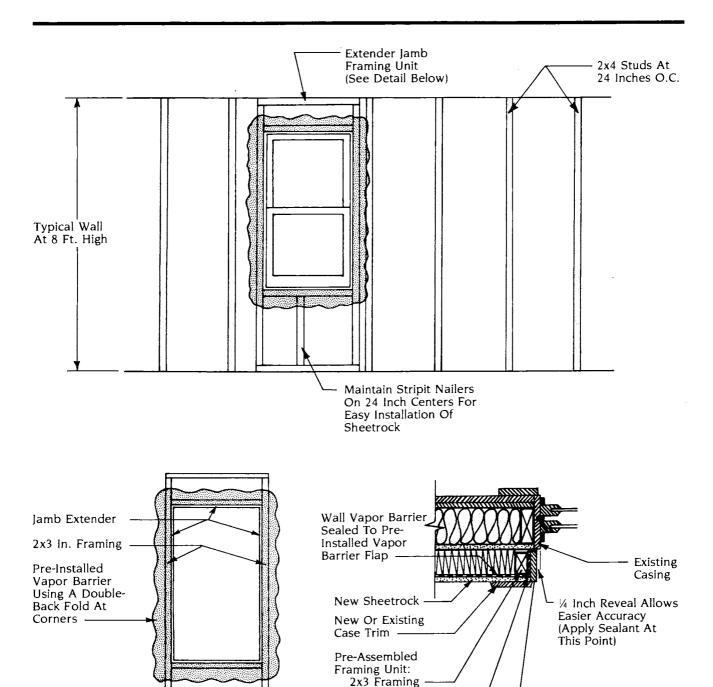
Pre-Assembled Extender Jamb Unit With Vapor Barrier In Place

FIGURE 2.14 Extra framing is required around window openings when rigid insulation is used.

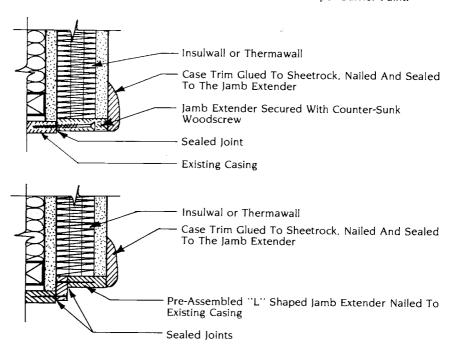
Using Either Scheme And Either Product, All Joints Between Sheets Are Sealed And All Wall Surfaces And Case Trim Is Painted With Vapor Barrier Paint.

FIGURE 2.15 Jamb extenders need to be sealed when using rigid insulation.

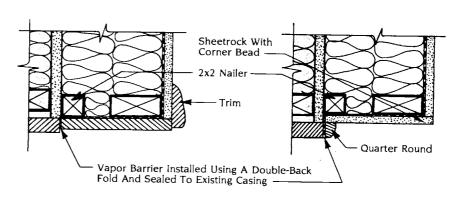
34 In.x7½ In. Wood Jamb Extender And Trim

Sheetrock Surround And Corner Bead.

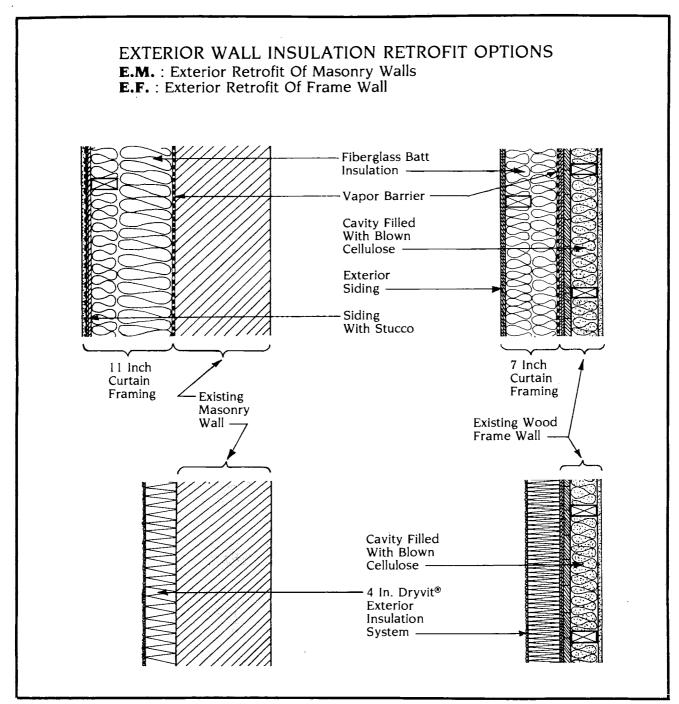
FIGURE 3.2 Exterior wall insulation retrofit options. These four exterior wall sections show representative insulation materials and framing techniques used in the following discussion. These same architectural materials symbols appear throughout the text.

The Larsen truss system also leaves a large cavity for fiberglass insulation. The two Larsen truss walls shown (E.F.3 and 4) don't differ much in either cost or R-value whether the existing cavity is filled or left empty (Figure 3.8.).

E.F.5 reaches R-26 at a cost of \$.17/R-sq.ft., demonstrating that a large share of the curtain wall costs are fixed regardless of depth of the retrofit (Figure 3.9). Once those fixed costs are incurred in a

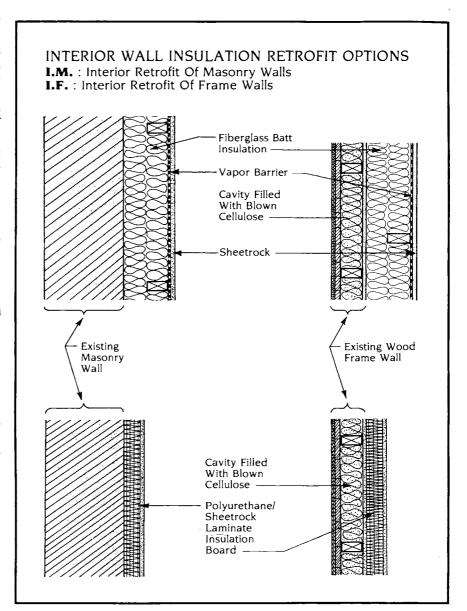
FIGURE 3.3 Interior wall insulation retrofit options. These four interior wall sections show representative insulation materials and framing techniques used in the following discussion. These same architectural materials symbols appear throughout the text.

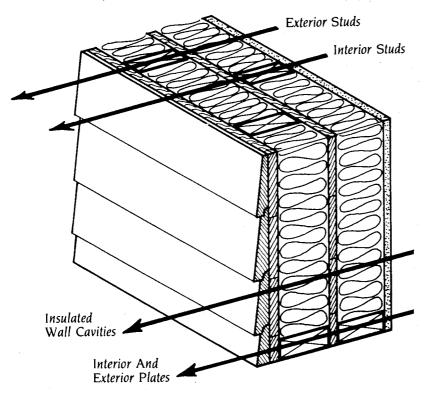
Fig. A1 Heat Flow Paths This drawing shows four different heat flow paths through a wood frame wall retrofitted with interior stud framing.

For example, a 2×4 stud wall with 3½ inches of fiberglass batt insulation has two different parallel heat loss paths; through the studs or through the insulation. In an 8×8-foot section of this wall you will find that 14 percent of the wall area is made up of studs and plates and 86 percent is insulation. Thus the framing correction factors for this wall are .14 (heat loss through studs) and .86 (heat loss through the insulation).

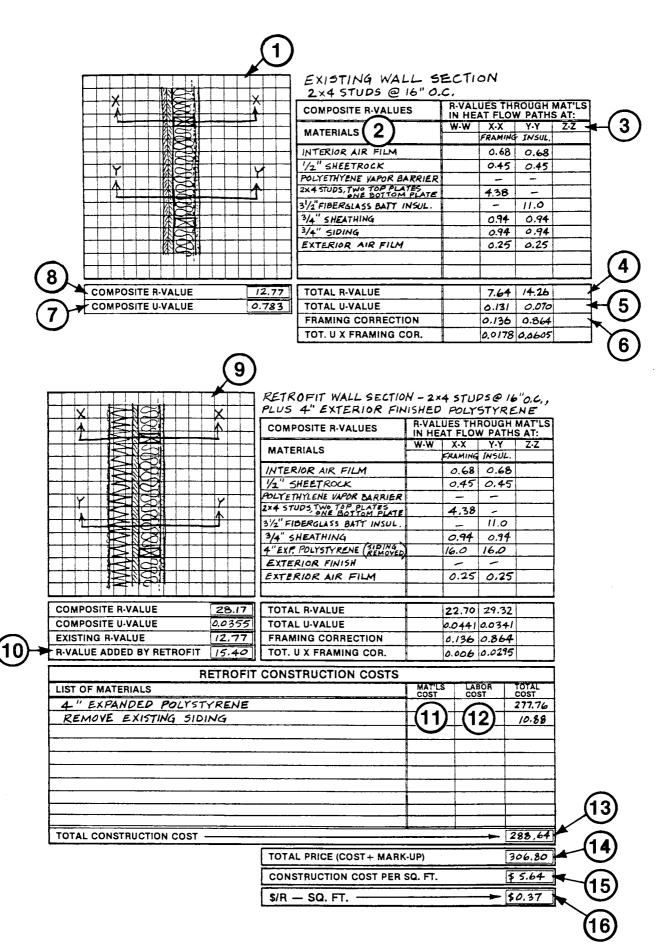
Fig. A-3 Example of \$/R-Sq.Ft. Calculations

The sample shown here is for a wall retrofit. The same technique may be used for other parts of the building with minor exceptions. First remember that the R-value for air films and air spaces is different depending on whether the direction of heat flow is horizontal, upward, or downward. For slabs and below grade walls, there is no outside air film. Calculating heat loss to the surrounding earth from slabs and basements is very complex, but it can be ignored when you calculate the cost/sq.ft./R for below-grade.
